BUREAU OF SHIPS GROUP TECHNICAL INSPECTION REPORT

U.S.S. ARDC 13

⑥ OPERATION CROSSROADS. Defense Atomic Support Agency
Washington, D. C. 20301

DETAILED DESCRIPTION OF HULL DAMAGE

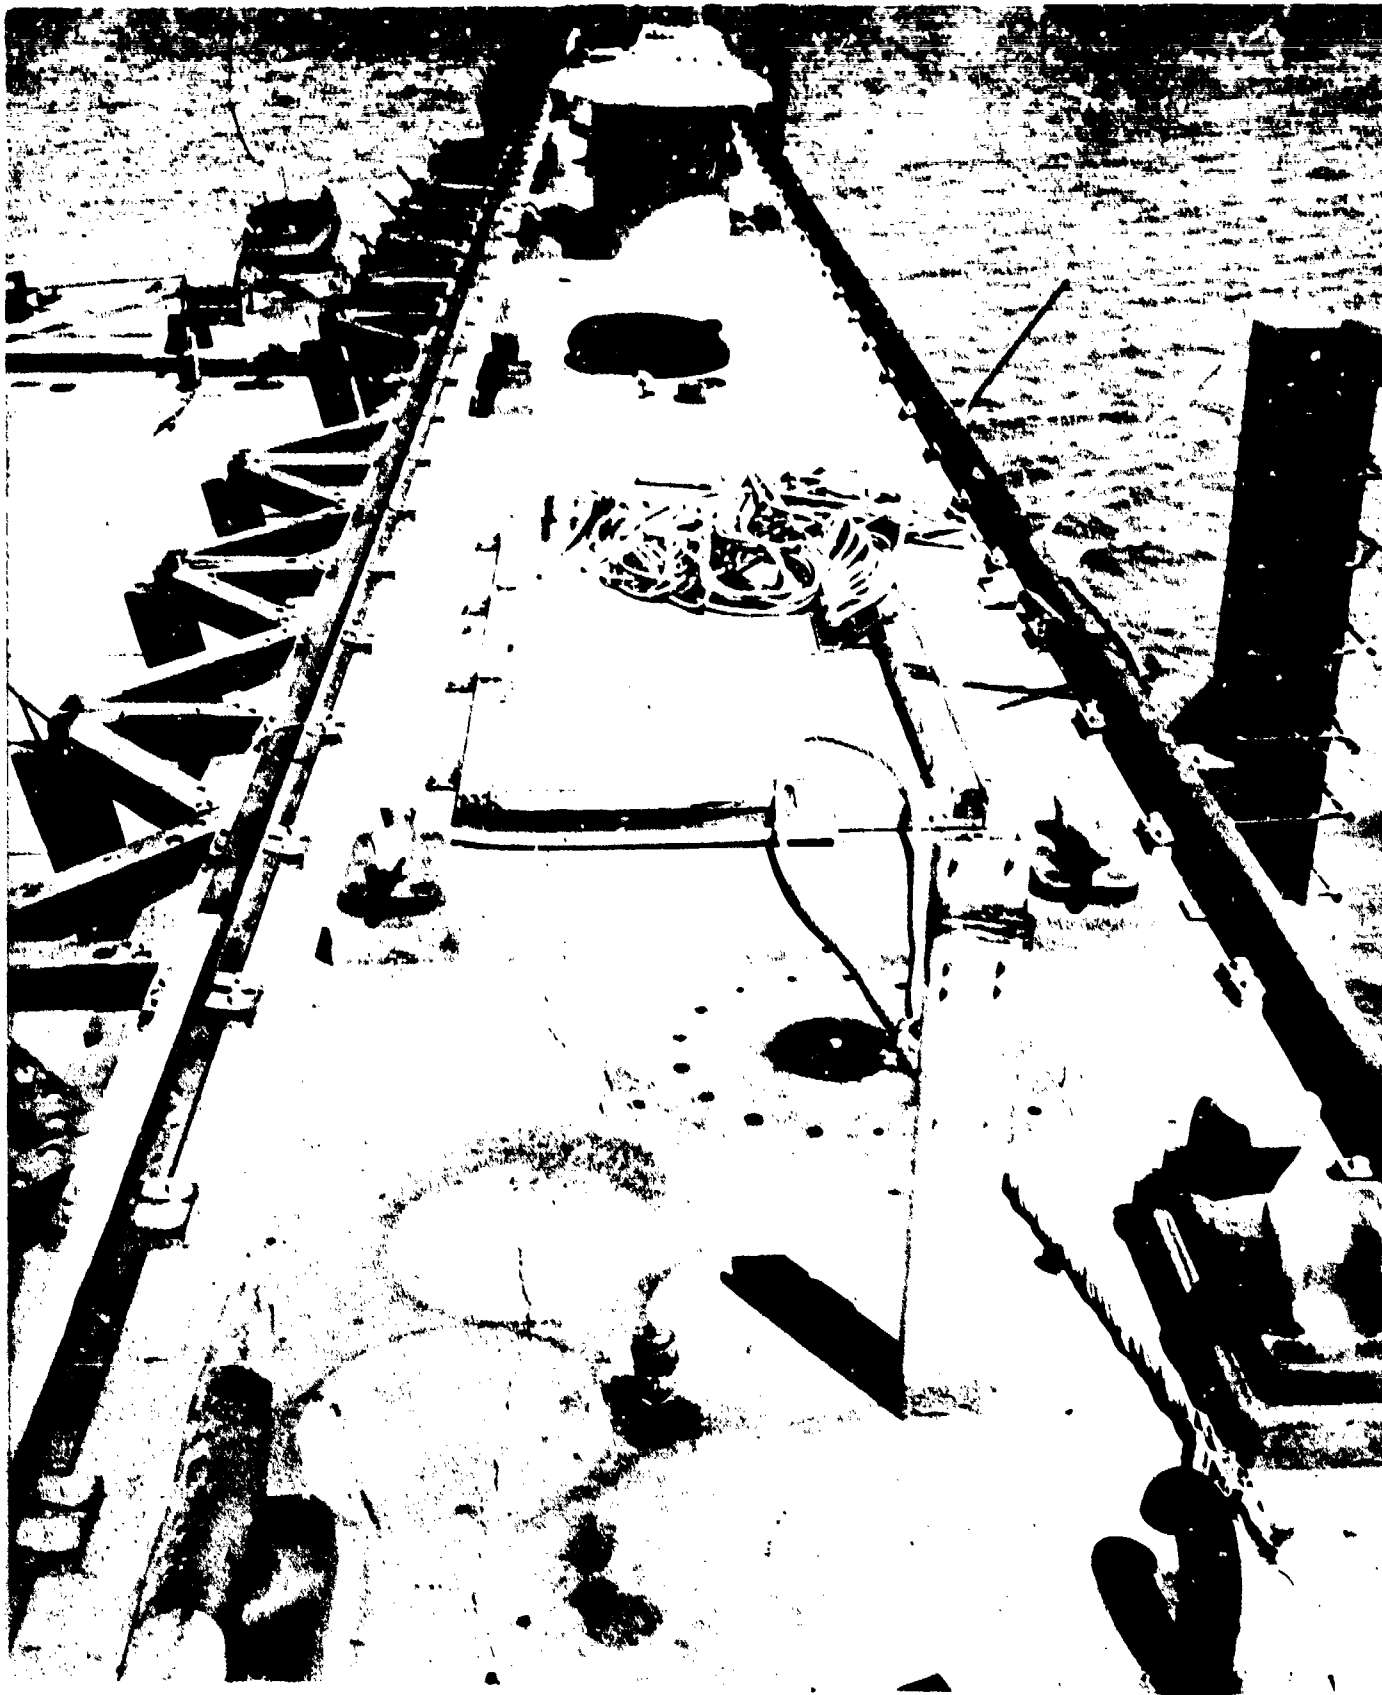
AA-CR-82-1916-1. View looking forward, starboard side, showing crack in "A" deck.

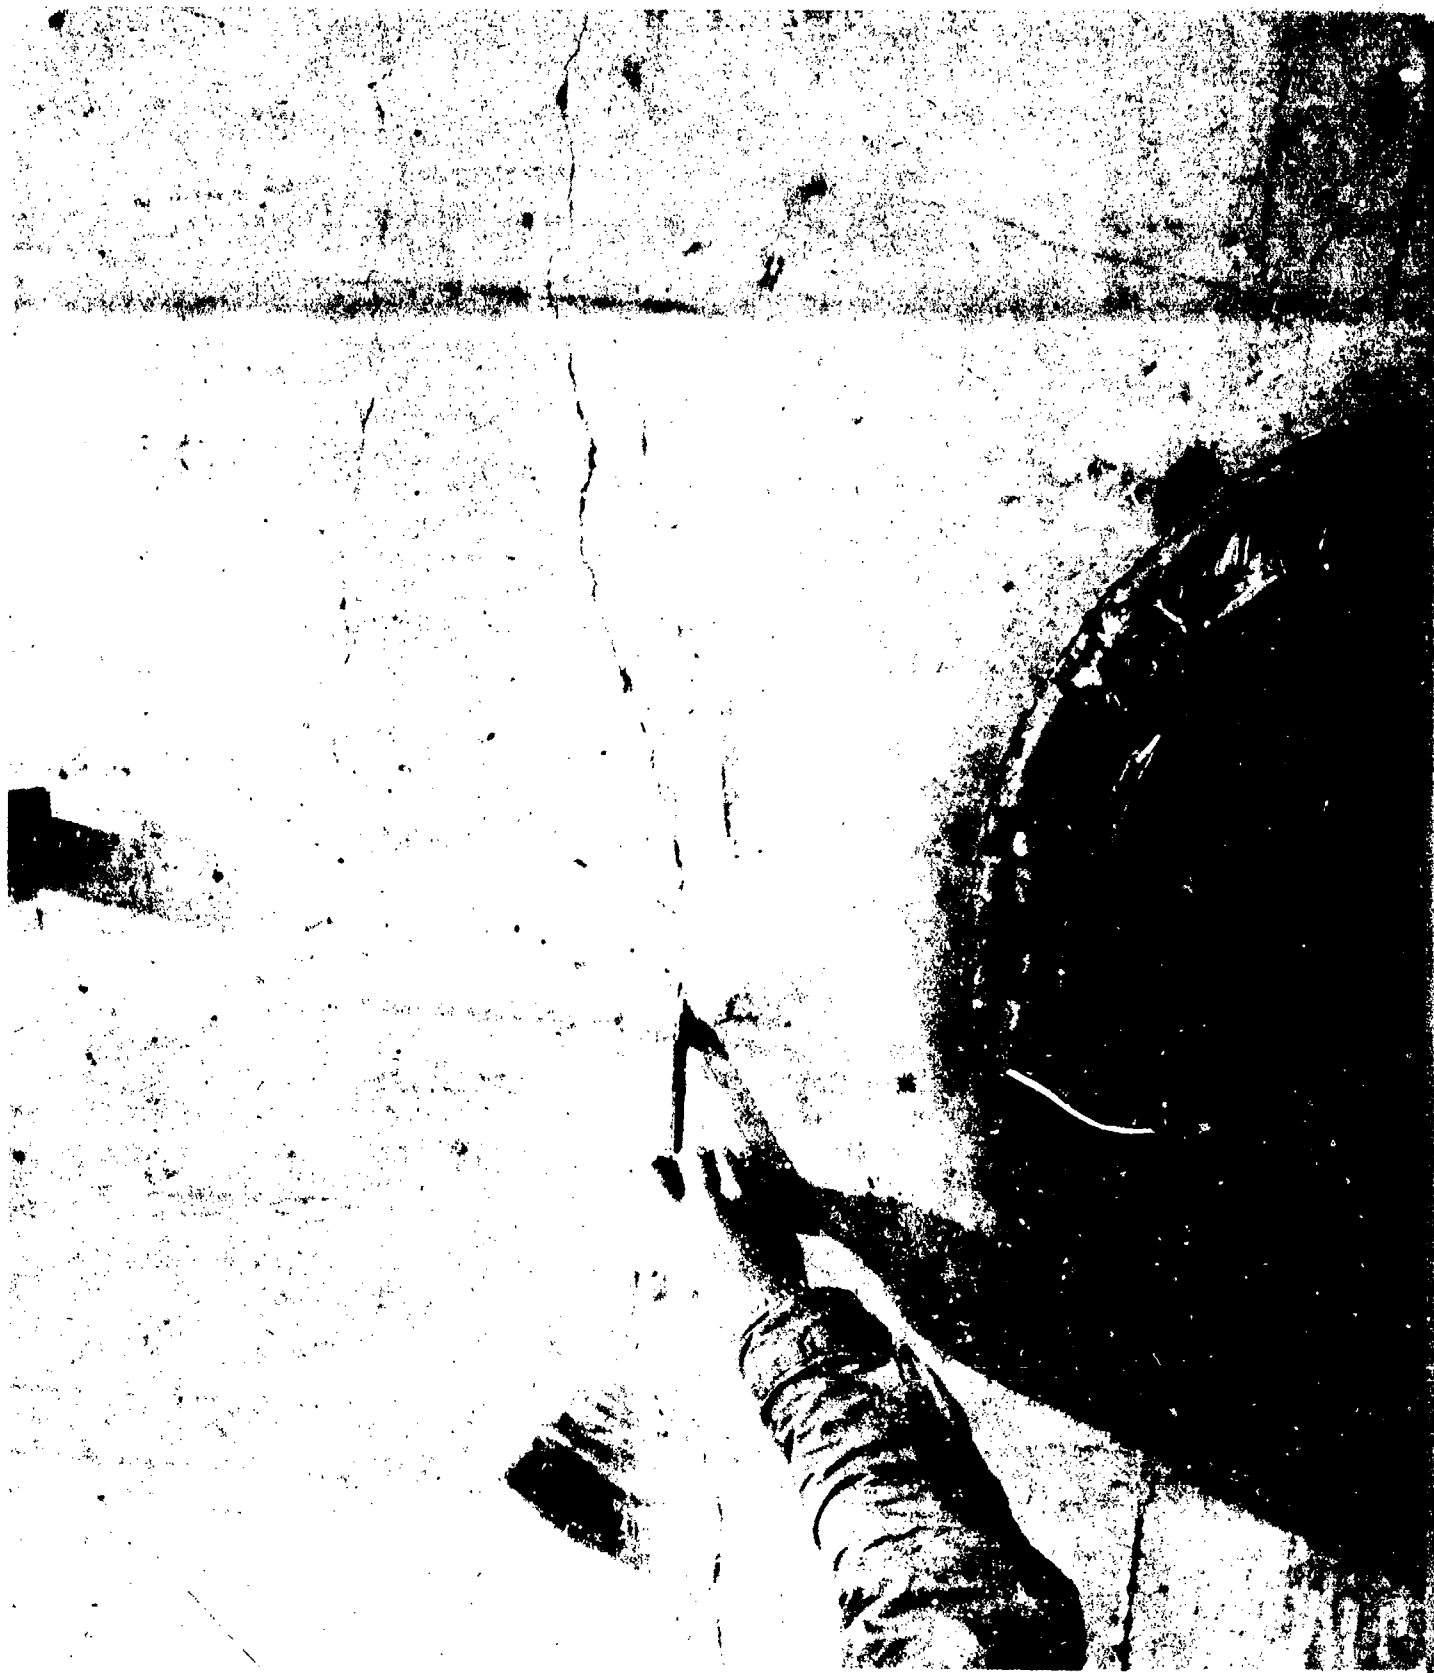
The inboard face of the port wall amidships contains longitudinal cracks running four to five feet from the top of the wall, and at about midheight (Photo 1914-11, page 62). There is a continuous set of cracks running about five feet above the floor on the starboard wall (Photos 1916-2, 1963-5, pages 61 , and 65).

AA-CR-98-1963-5. View of crack in after inside face of starboard wing wall.

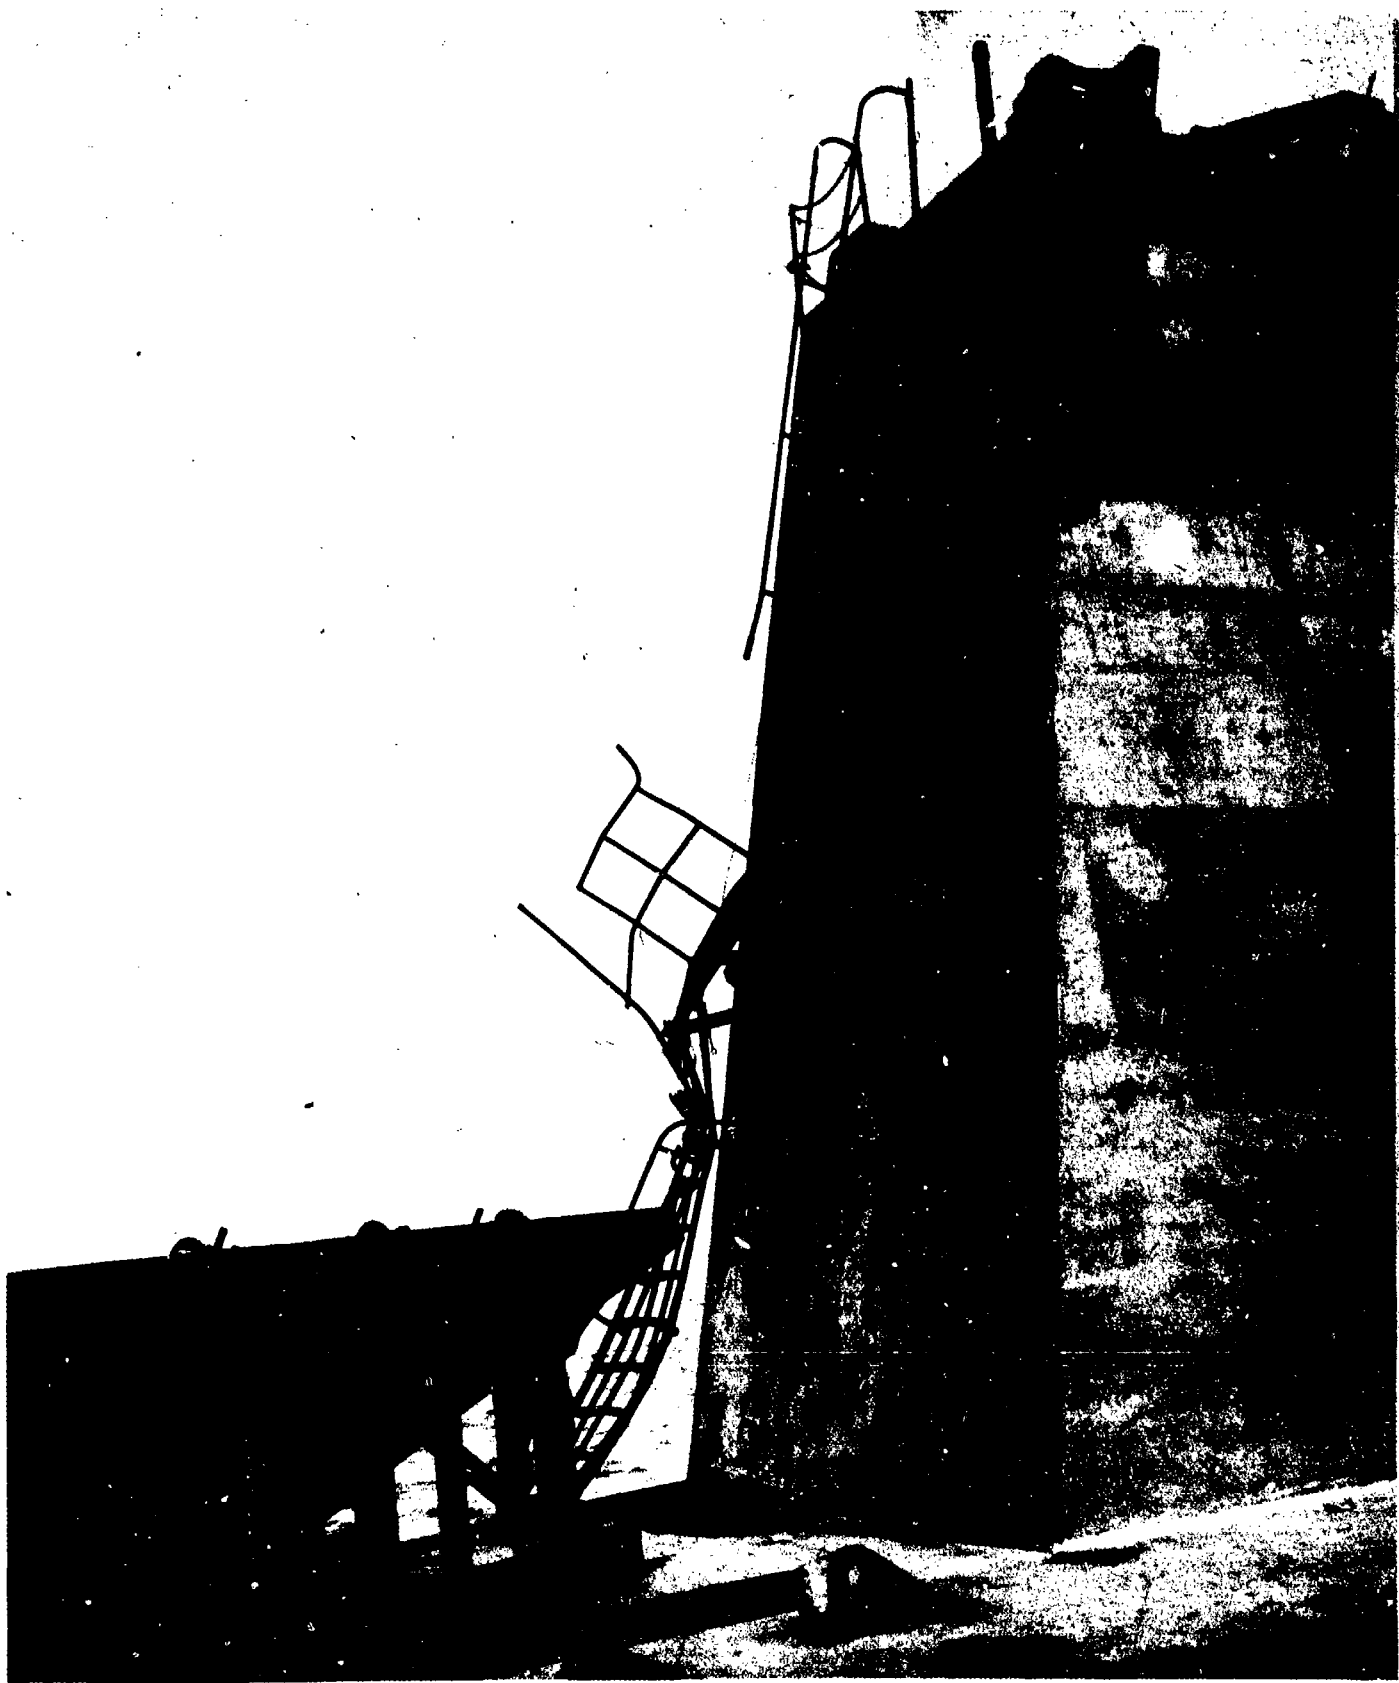
AA-CR-98-1963-11. View of damage to ladder on forward face of starboard wing wall.

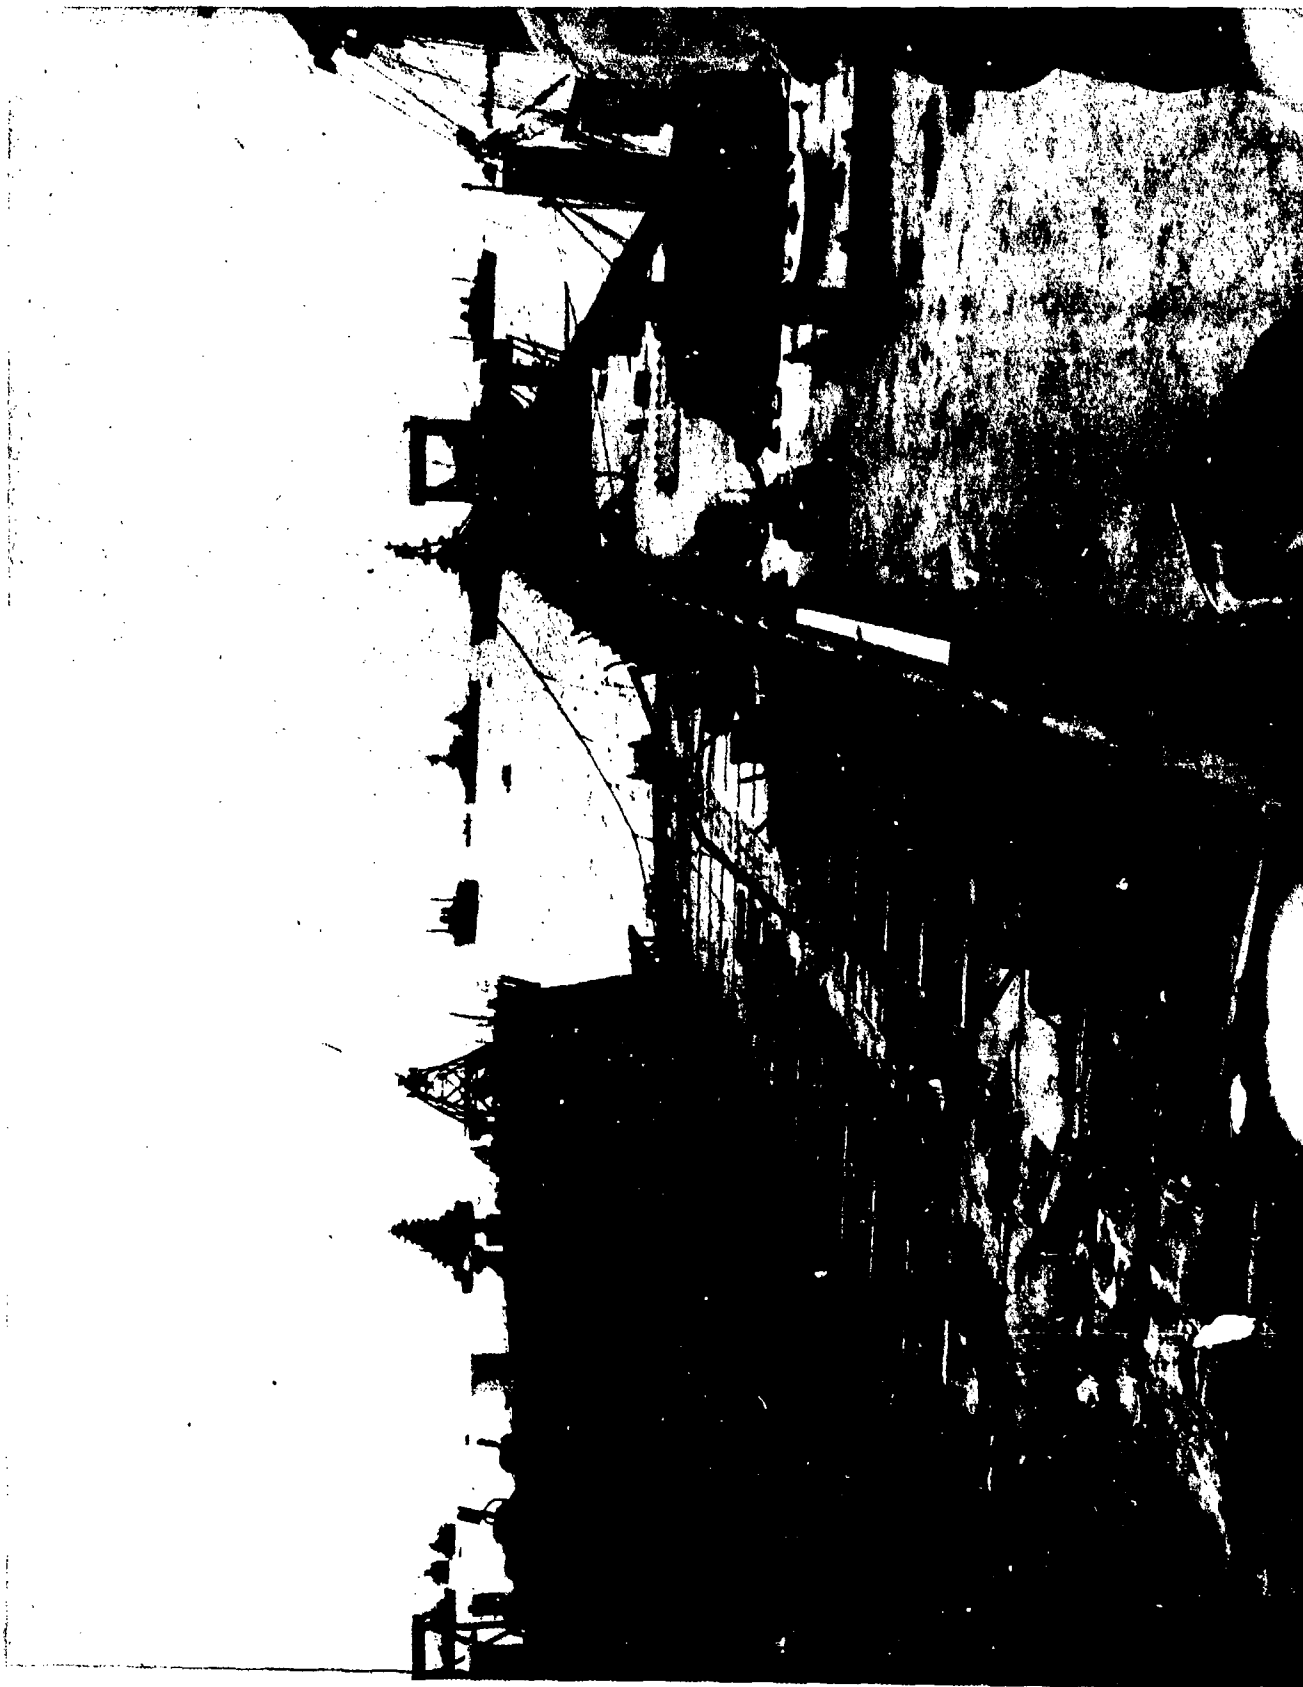
AA-CR-98-1962-10. View looking forward from top of starboard wall.

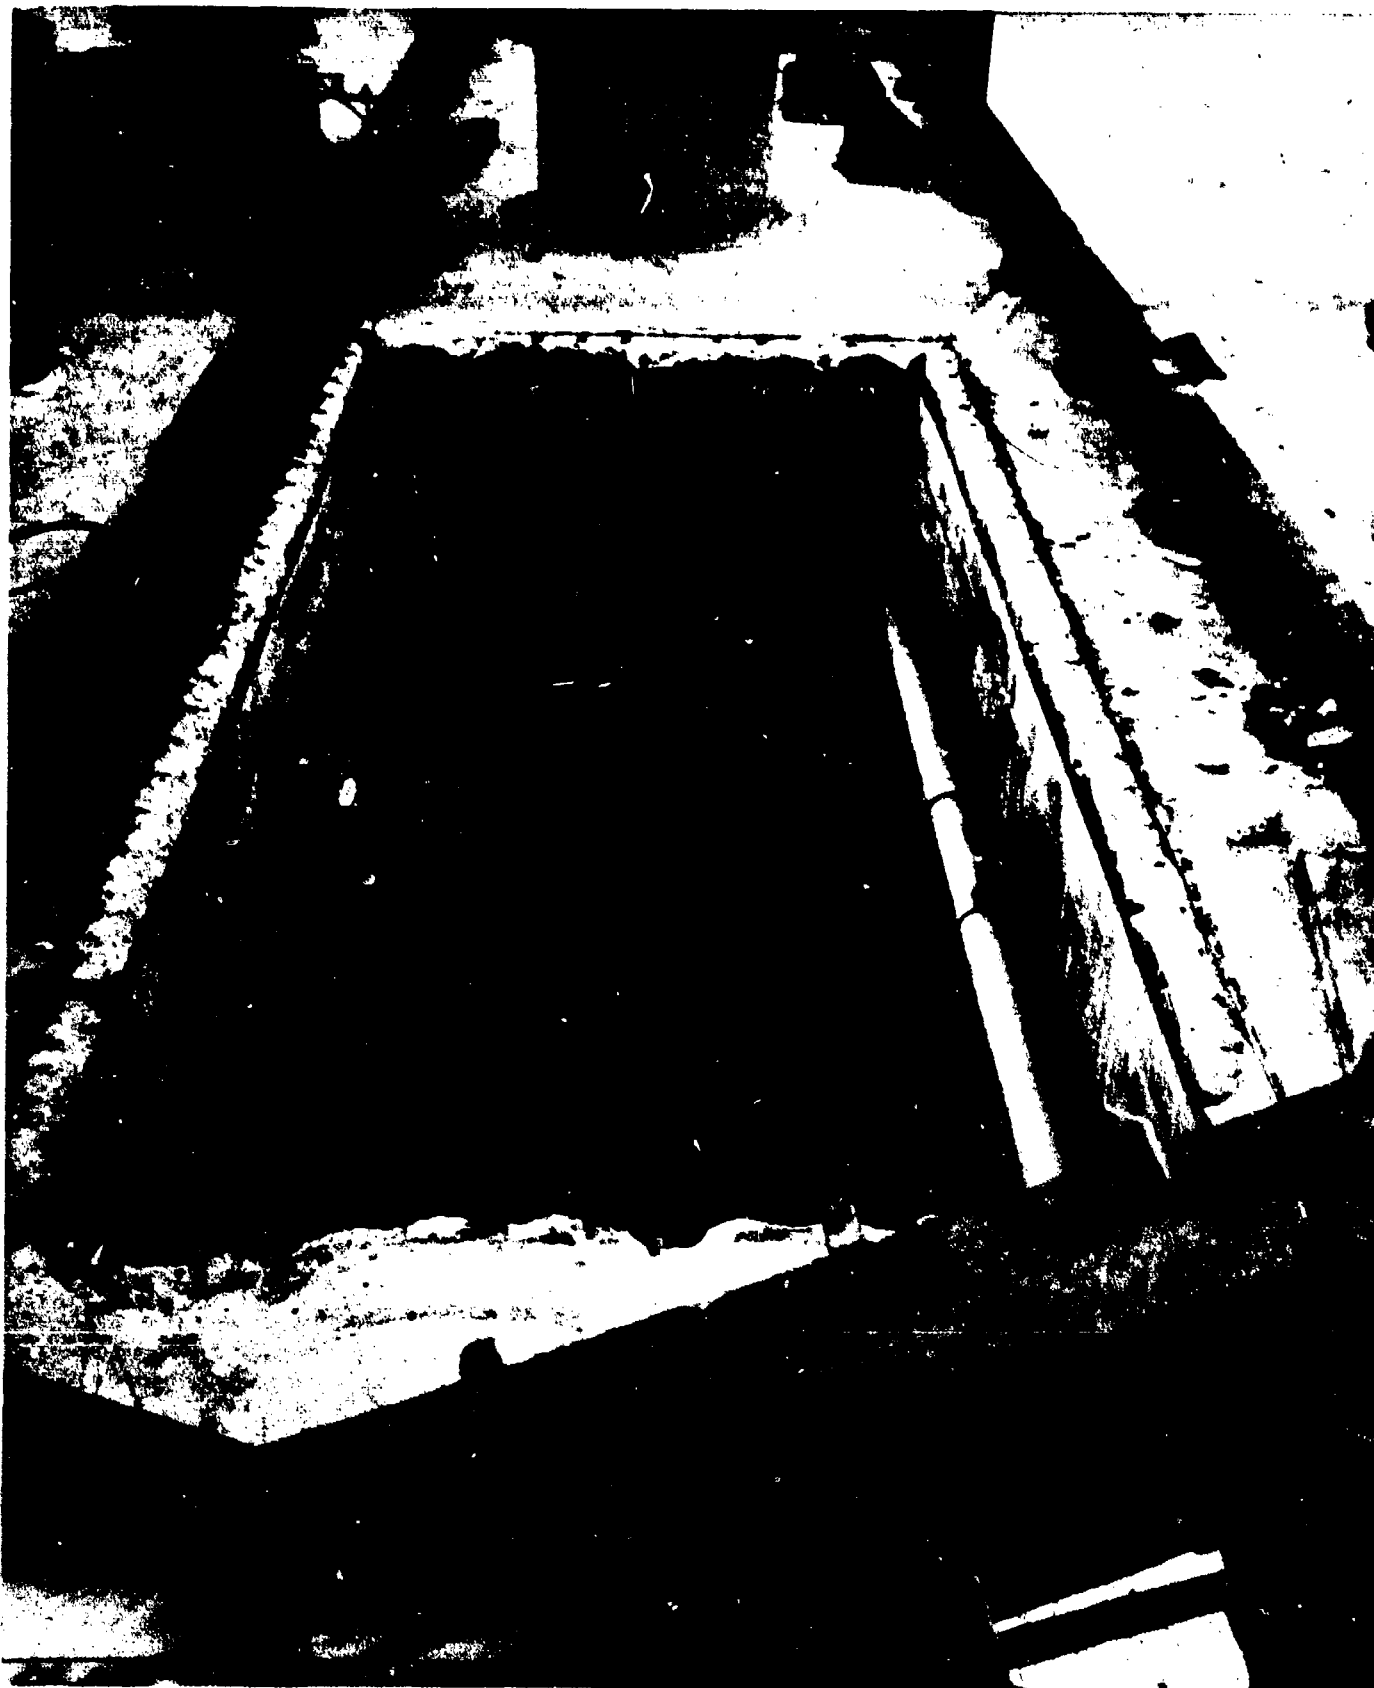
AA-CR-98-1964-2. View looking aft at engine room hatch opening in port "A" deck. The cover plate and hatch are missing - see 1914-4 for typical installation.

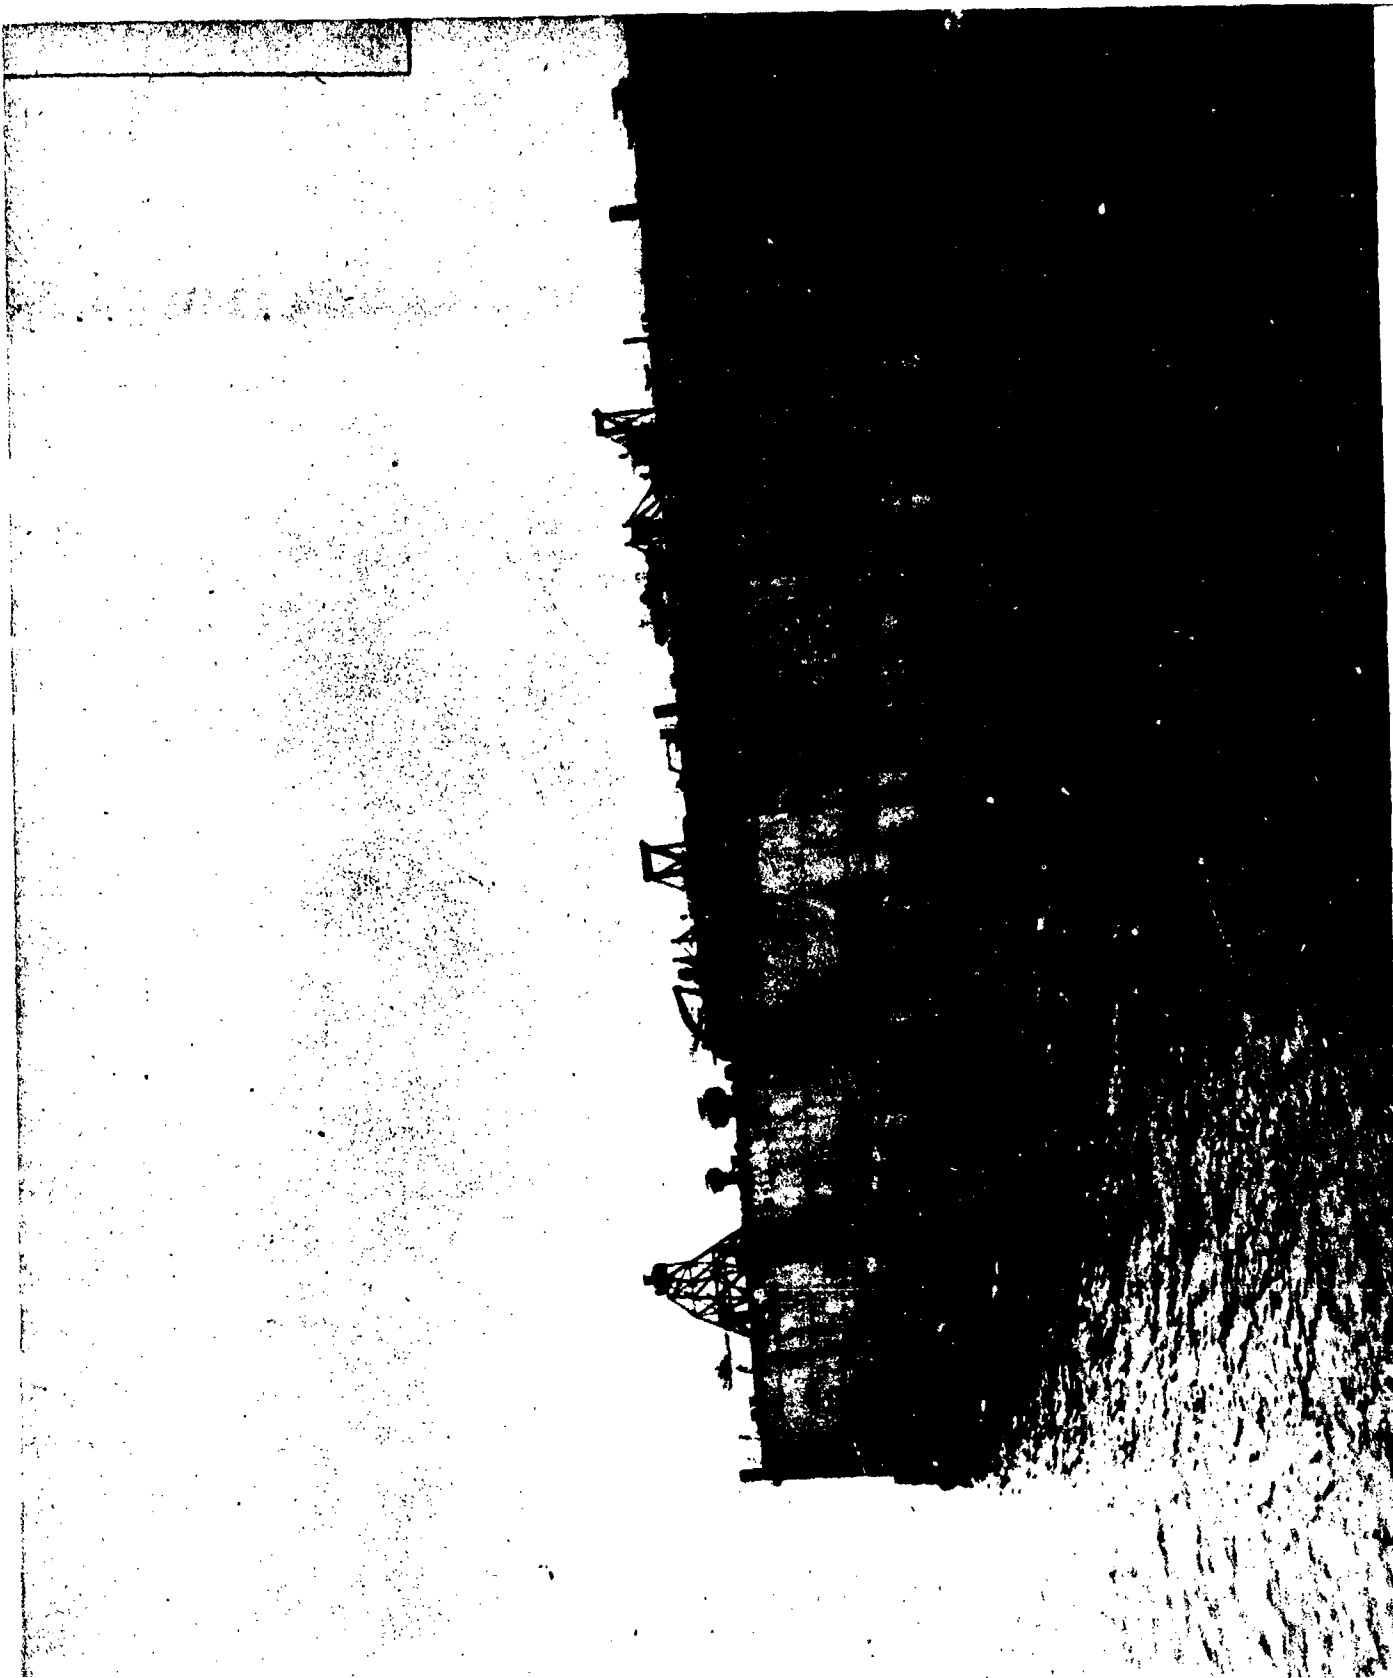
The exterior face of the port wall was darkened by radiated heat and the extensive timber fender system is charred to a depth of about 1/16 inch. (Photo 1964-10, page 78). There is a well defined crack running almost the length of the deck in line with the connection of the wall to B deck. There is a small crack extending through the port shell slab about six inches below the waterline running between frames 18 and 55. The crack was reported leaking over about one fourth of its total length. Outside of this one crack, the underwater damage is considered to be relatively minor.

AA-CR-98-1964-10. View of exterior face of port wing wall looking
aft from off port bow.

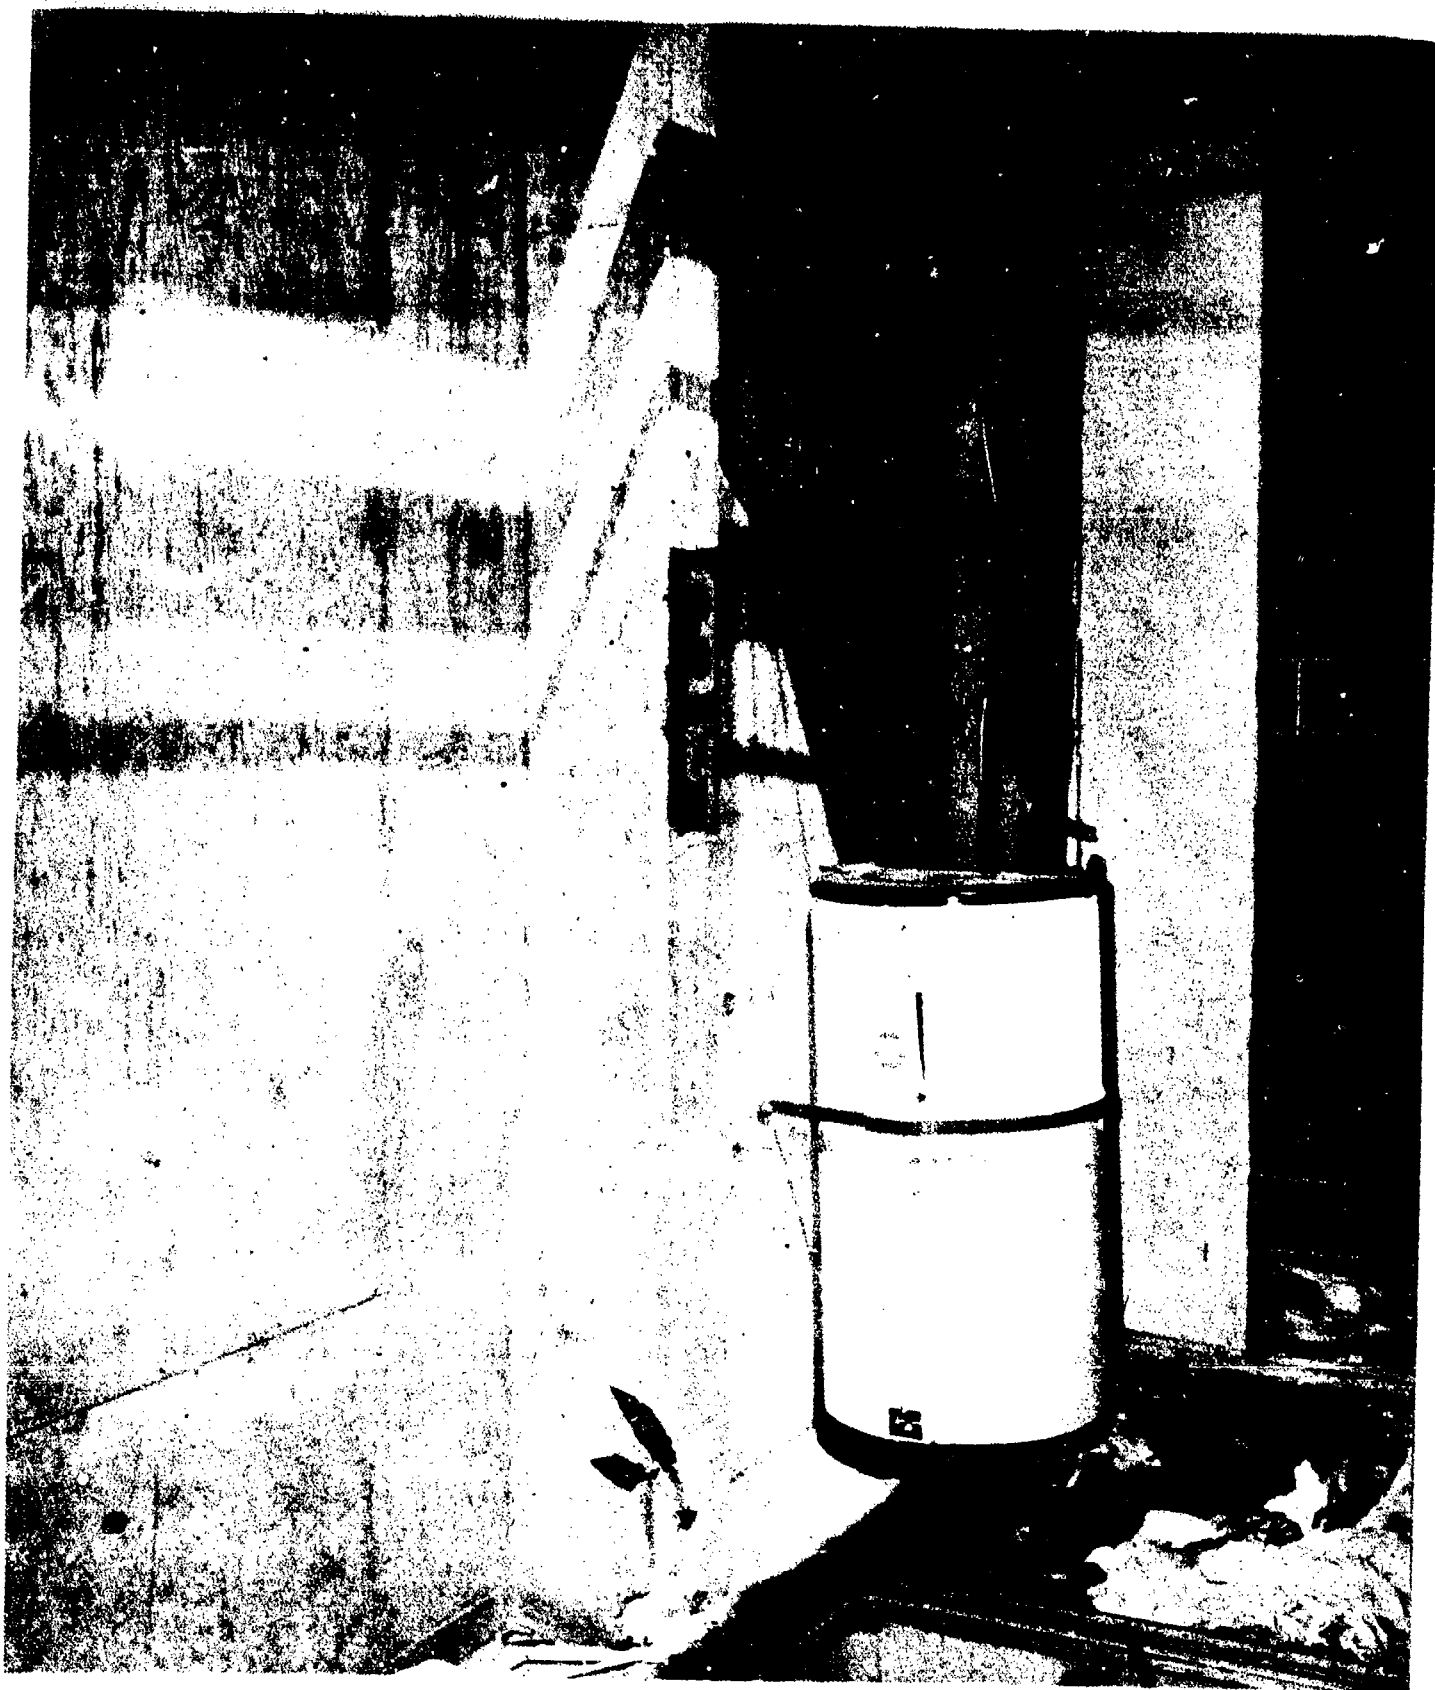
deck levels (Photos 1914-6, 1914-7, 1914-10, pages 79 , 80 , and 81). On the starboard side, only the wing frames were affected. These have fine structural cracks about four feet above the B deck level. The port wing wall has two large areas that are over stressed. Structural, longitudinal cracks run between frames 25 and 40 at about B deck level, and about three feet below A deck. Structural bulkheads between frames 19 to 44, port, on B deck, are badly damaged. Concrete here has spalled, exposing the reinforcing bars. The watertight integrity of these bulkheads is impaired. (Photos 1914-8, 1914-5, pages 82 , and 83).

AA-CR-32-1914-6. Typical damage is shown at the base of frame 39, port side, looking forward.
